# Assessment of the Quality, Health, Safety, and Environment (QHSE) Management System at Petrol Stations in the Mont-Amba District of Kinshasa, Democratic Republic of the Congo

University of Kinshasa, Kinshasa, Democratic Republic of the Congo

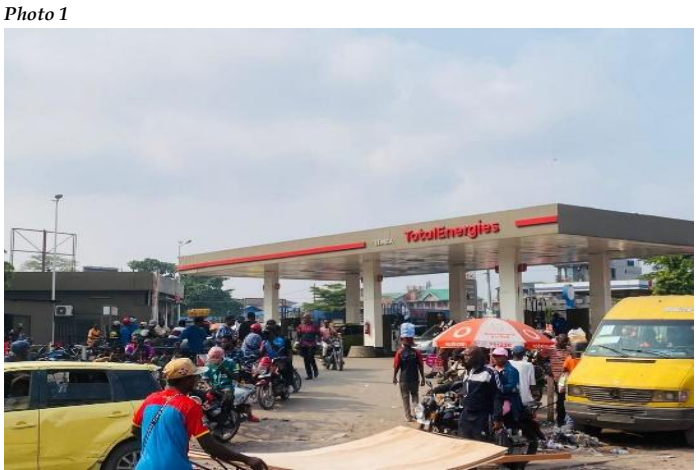
**Photos 1-3:**  
Representative forecourt hazards in Mont-Amba: severe vehicle congestion at Super Lemba (left); abandoned vehicles blocking forecourt lanes at 'La Grandie Lemba' (center); fuel pumps positioned directly adjacent to residential housing (right)

Field investigations documented severe visual, physical, and operational hazards. Forecourt congestion routinely disrupted major thoroughfares (Photo 1), while abandoned vehicles occupied pump access routes (Photo 2). Furthermore, several pump dispensers were constructed immediately adjacent to high-density, multi-story residential structures (Photo 3).
